INSULATED CONTAINERS FOR BOTTLED WATER (ICB) – PERFORMANCE EVALUATION

April 2017

Final Report July 2013 – January 2014

U.S. Army Natick Soldier Research, Development and Engineering Center Natick, Massachusetts 01760-5000

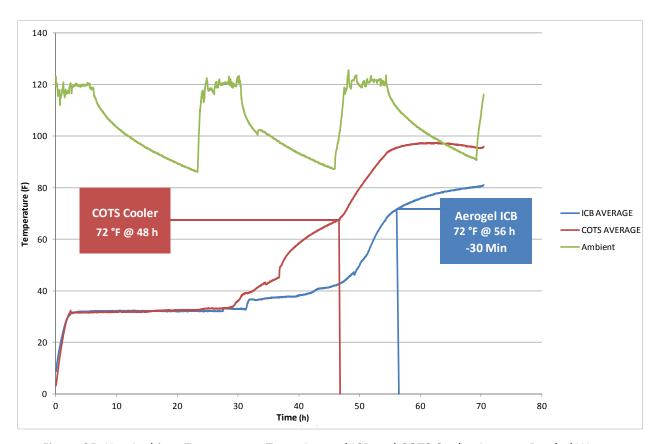
Figure 25: Hot Ambient Temperature Test –Aerogel ICB and COTS Cooler Average Bottled Water Temperatures

Figure 25 shows the average bottle temperature in the Aerogel ICB and COTS cooler throughout the 80 h of testing. The COTS cooler had similar performance to that of the large ICB, as shown in Figure 24. This was most likely due to the COTS cooler's foam insulation, which had a higher R-value (of about 5 per in) than the ICB double bubble insulation (about 3 per in). The COTS cooler's white plastic lid also allowed for a higher reflectivity of solar radiation than any of the ICBs, aiding in its cold storage hold time performance.

The Aerogel ICB performed the best of all the containers tested, no matter what size. It provided a cold storage hold time which was 26 h and 50 min more than the comparably sized medium double bubble ICB and 8 h and 30 min more than the comparably sized COTS cooler. This increase in cold storage hold time performance is solely due to its Aerogel insulation, which had an R-value of 10.3.

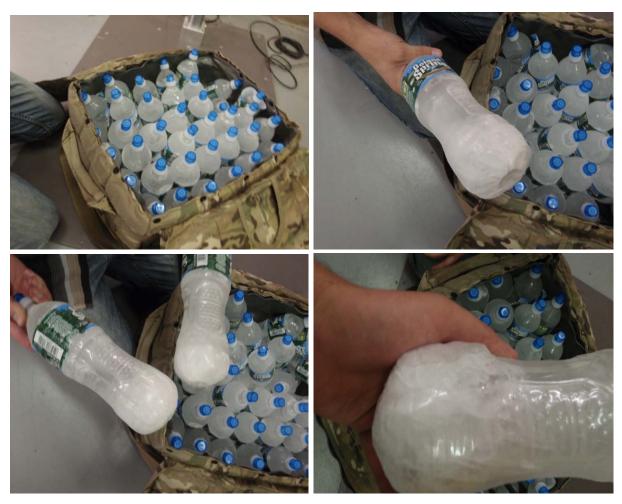
Figure 27: Large ICB Drop Test with Bag Bottom Facing Down

The initial drop with the bag bottom facing down (Figure 27) caused only minor damage/cracking on three of the bottles contained within. No damage to the bag was noted.

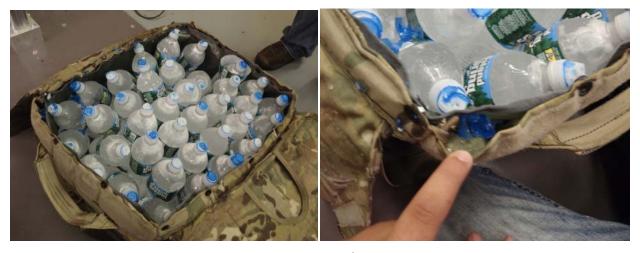
Figure 28: Large ICB Drop Test with Bag Top Facing Down

Dropping the bag with the top facing down (Figure 28) caused damage to all the bottles' caps, causing them to break off or be crushed.

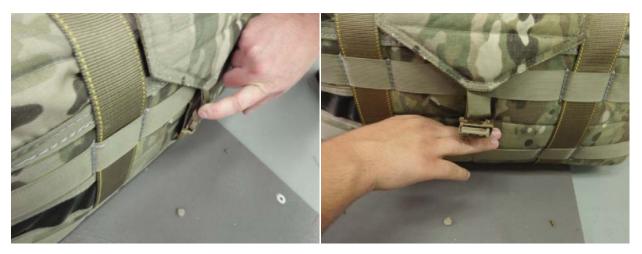
Figure 29: Large ICB Drop Test with Access Flap Facing Down

Dropping the bag with the access flap facing down (Figure 29) caused the access flap's buckle to break. It should be noted that these buckles are replaceable without tools.

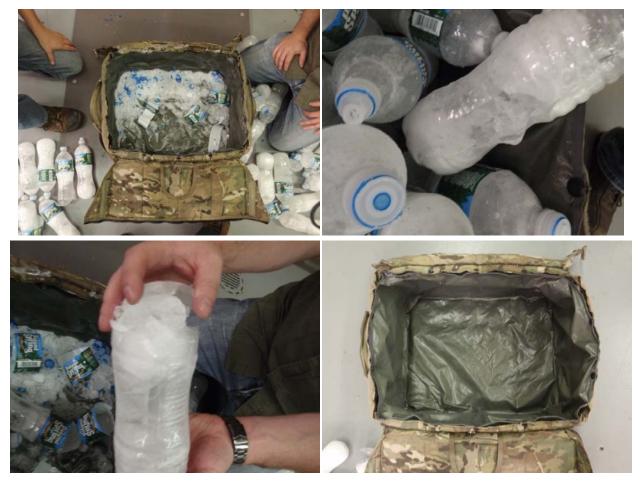
Figure 30: Large ICB Drop Test, Subsequent Drops

Subsequent drops on the remaining three sides (Figure 30) caused additional damage to the bottles, resulting in about 50% of the bottles being destroyed. No additional damage to the bag was noted. No damage to the internal liner was noted.

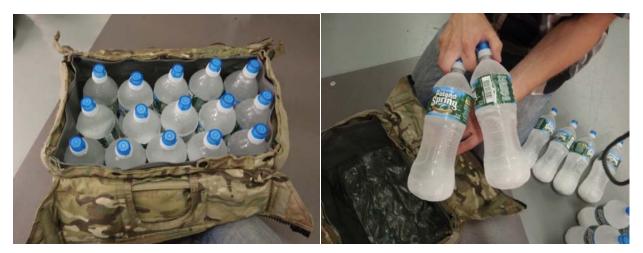
Figure 31: Medium ICB Drop Test with Bag Bottom Facing Down

The initial drop with the bag bottom facing down (Figure 31) showed only minor damage/cracking on two of the bottles contained within. No damage to the bag was noted.

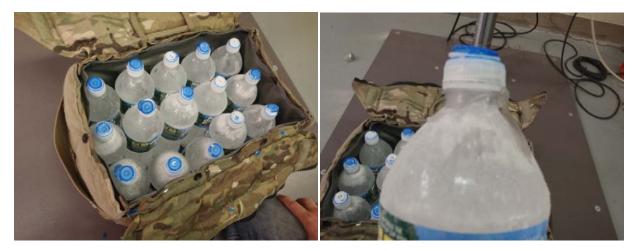
Figure 32: Medium ICB Drop Test with Bag Top Facing Down

Dropping the bag with the top facing down (Figure 32) caused damage to all the bottles' caps; they either broke off or were crushed. A couple of the bottles also cracked at the neck

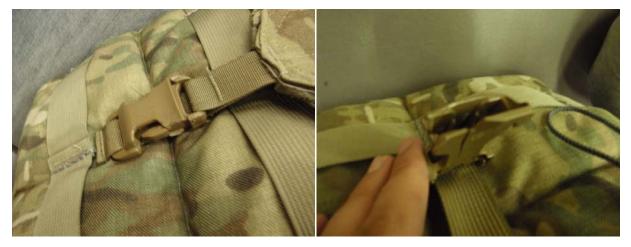
Figure 33: Medium ICB Drop Test with Access Flap Facing Down

Dropping the bag with the access flap facing down (Figure 33) caused the access flap's buckle to break. It should be noted that these buckles are replaceable without tools.

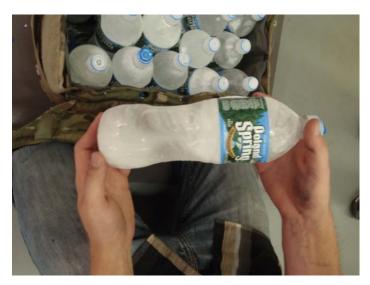
Figure 34: Medium ICB Drop Test, Subsequent Drops

Subsequent drops on the remaining three sides (Figure 34) caused some additional minor damage to a couple of the bottles. No additional damage was noted on the bag or the liner.

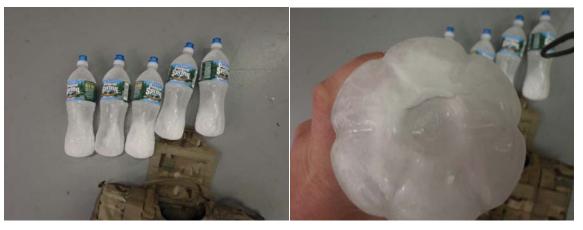
Figure 35: Small ICB Drop Test with Bag Bottom Facing Down

The initial drop with the bag bottom facing down (Figure 35) showed only minor damage/cracking on the bottom of the center bottle. No damage to the bag was noted.

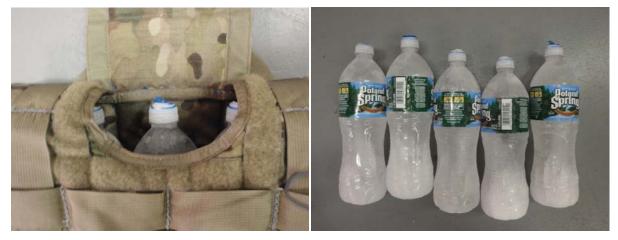
Figure 36: Small ICB Drop Test with Bag Top Facing Down

Dropping the bag with the top facing down (Figure 36) caused damage to all the bottles' caps; they either broke off or were crushed.

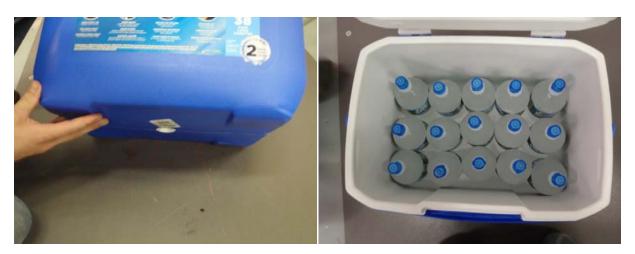
Figure 38: COTS Cooler Drop Test with Bottom Facing Down

The initial drop of the COTS cooler with the bottom facing down (Figure 38) resulted in minor crushing of the bottom corners of the cooler. No damage to the bottles was noted. No bottles escaped the cooler.

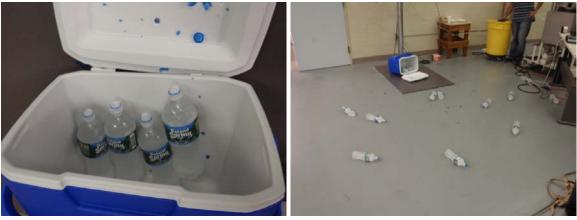
Dropping the COTS cooler with the top facing down (Figure 39) resulted in damage to all but two of the bottles' caps. All but three bottles were ejected from the cooler upon impact. One of the hinges on the cooler's lid also broke upon impact.

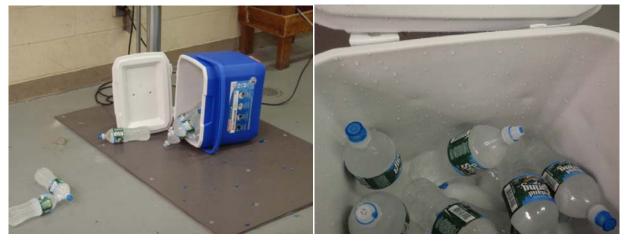
Figure 40: COTS Cooler Drop Test, Subsequent Drops

Subsequent drops on the remaining four sides (Figure 40) caused some internal damage to the cooler in the form of dents. The other hinge did not break, but was warped somewhat due to the asymmetrical mounting of the lid. No substantial additional damage to the bottles was noted on the subsequent drops.

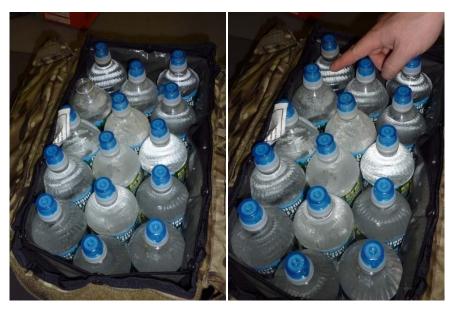
Figure 42: Aerogel ICB Drop Test with Bag Bottom Facing Down, Subsequent Drops

Subsequent drops with the bottom facing down (Figure 42) caused no damage to the bag and only minor damage to only one bottle; the cap was blown off, but was undamaged and was re-threaded.

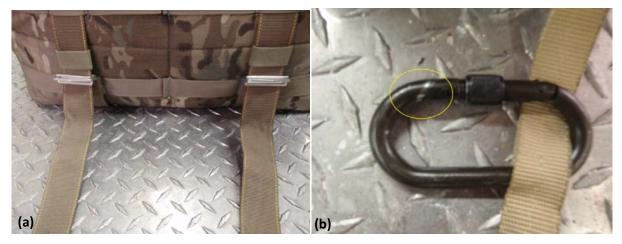
When the UTD method was used, the large ICB sustained minor abrasion and stretching on its integrated tie-down straps (Figure 44a). The carabiners attached to the UTD straps also sustained minor abrasion wear in the areas that were contacting the mounting tray (Figure 44b). All bottles remained in the container throughout the test.

Figure 44: Vibration Test Results for Large ICB using UTD Method: (a) Abrasion on Tie-Down Straps; (b)

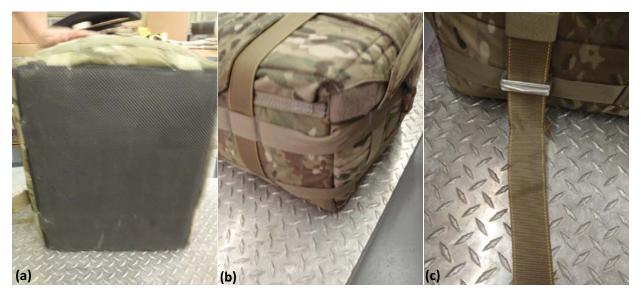
With the STD method, some abrasion wear and scuffing were noted on the bottom of the ICB (Figure 45a). Some additional stretching was noted on the bag's MOLLE webbing (Figure 45b) and on the integrated tie-down straps (Figure 45c). This was most likely due to the additional give of the 550 paracord. All bottles remained in the container throughout the test.

Figure 45: Vibration Test Results for Large ICB using STD Method: (a) Abrasion on Bottom of ICB; (b) Stretching on MOLLE Webbing; (c) Stretching on Straps

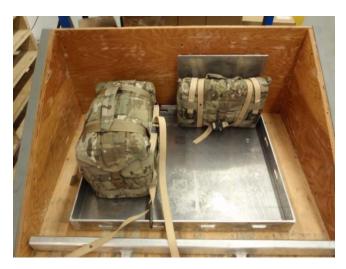
No damage or stretching was seen during the medium and small ICB test using the UTD method (Figure 46). All bottles remained in the containers throughout the test.

Figure 46: Vibration Test Results for Medium and Small ICBs using UTD Method

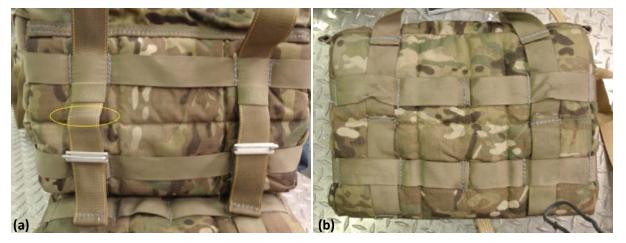
When using the STD method, however, minor abrasion wear was seen on one of the integrated tie-down straps of the medium ICB (Figure 47a). The small ICB also had some moderate deformation of the top row of webbing on the back of the ICB (Figure 47b). All bottles remained in the containers throughout the test.

Figure 47: Vibration Test Results for Medium and Small ICBs using STD Method: (a) Abrasion on the Straps of Medium ICB; (b) Deformation on Back Webbing of Small ICB

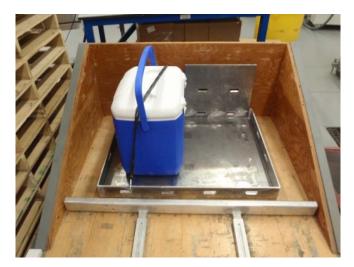
Figure 49: Vibration Test Results for COTS Cooler using STD Method

No damage to the COTS cooler was noted during the STD test (Figure 48) either. All bottles remained in the container throughout the test.

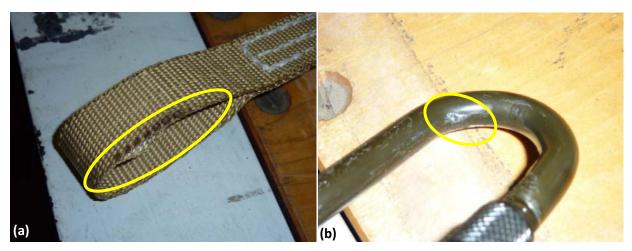
Figure 50: Vibration Test Results for Aerogel ICB using UTD Method: (a) Wear on End of UTD Strap; (b) Wear on Carabiner

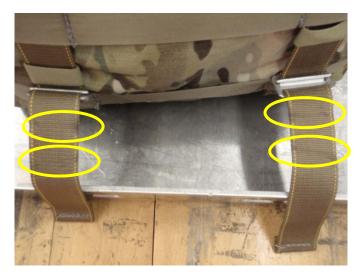
Figure 51: Vibration Test Results for Aerogel ICB using STD Method

During the test using the STD method, minor wear was seen on the Aerogel ICB's integrated straps, which fastened to the tray (Figure 51). This was most likely due to the play inherently given by the 550 paracord, which allows for more vertical motion than the UTDs.

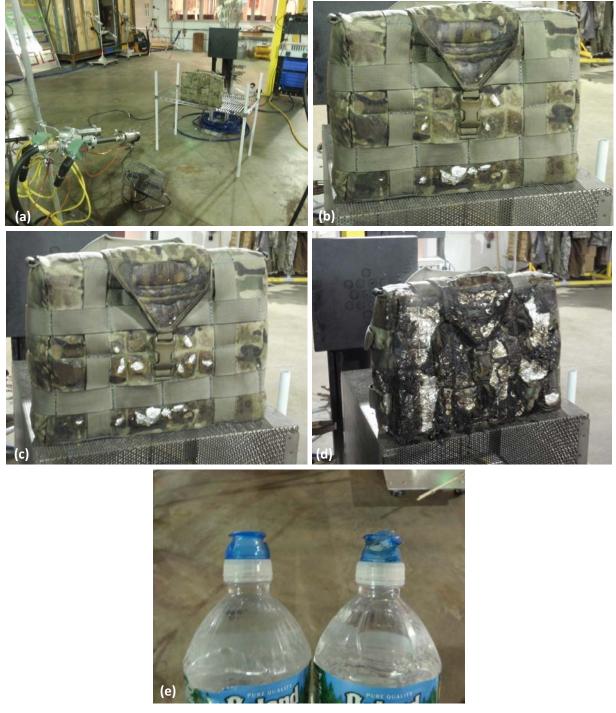
Figure 52: Small ICB Flash Oil Fire Test Results: (a) Test Setup; (b) After Initial 4-s Burn; (c) After Second 4-s Burn; (d) After Final 10-s Burn; (e) Damage on Bottles after 10-s Burn

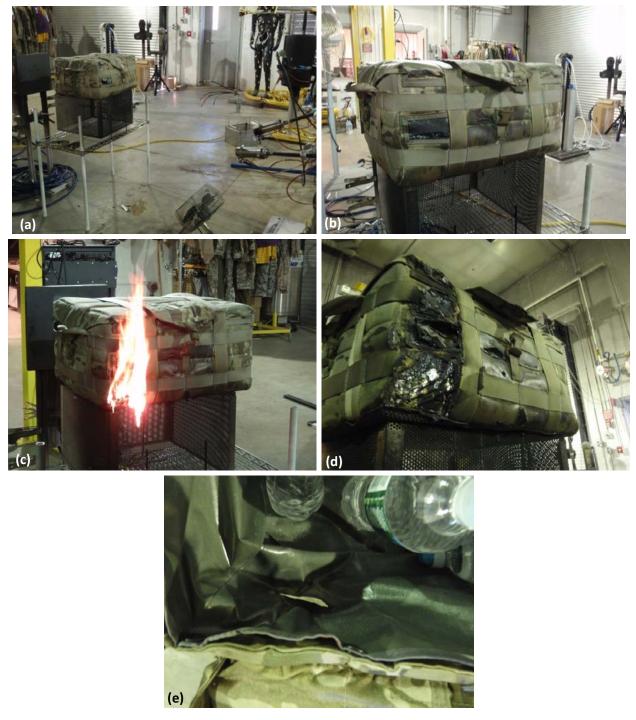
Figure 55: Large ICB Flash Oil Fire Test Results: (a) Test Setup; (b) After Initial 4-s Burn; (c) Sustained Ignition During Second 4-s Burn; (d) After Second 4-s Burn; (e) Interior after Second 4-s Burn

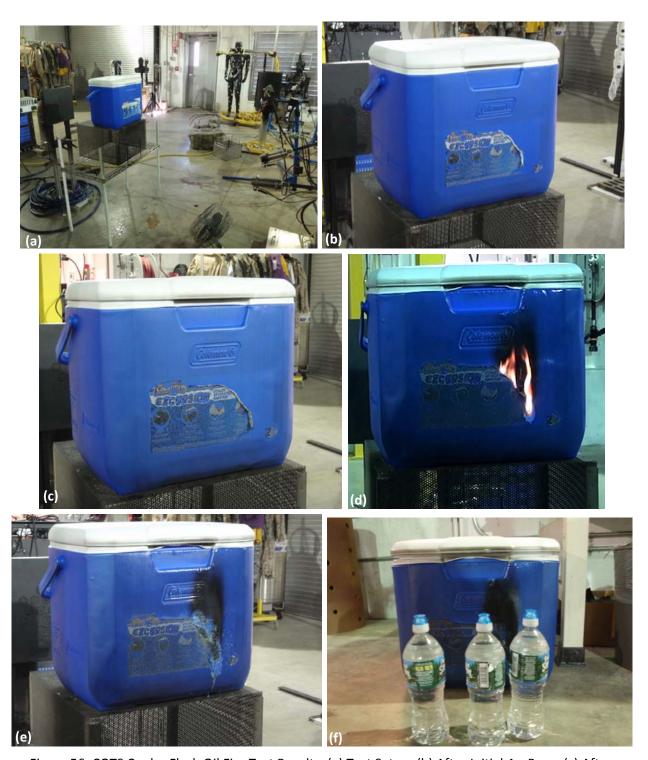
Figure 56: COTS Cooler Flash Oil Fire Test Results: (a) Test Setup; (b) After Initial 4-s Burn; (c) After Second 4-s Burn; (d) Sustained Ignition during 10-s Burn; (e) After 10-s Burn; (f) Undamaged Bottles with Damaged COTS Cooler after 10-s Burn

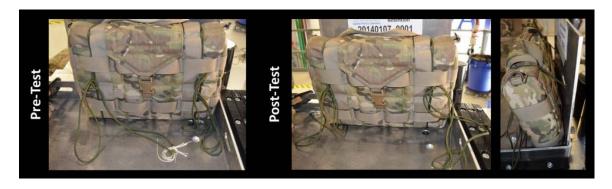
Figure 5 shows the pre and post-test state of the small ICB with the UTD as the primary restraint. Though no failures were noticed, the UTD was difficult to properly attach with a fully loaded ICB. It may be possible to route the UTD differently to better facilitate mounting of the ICB system while maintaining its performance as a restraint. The UTD was inspected and reattached after each test. The small ICB was typically tilted away from the back plate post-test similar to tests involving the paracord. Similar to the tests involving the paracord, high speed video showed that the system moved upwards before being restrained, with a greater amount of displacement. Similar response characteristics were noted for both the 7 and 9 m/s tests.

Figure 6: Small ICB with UTD pre-test (left) and post-test (right) state

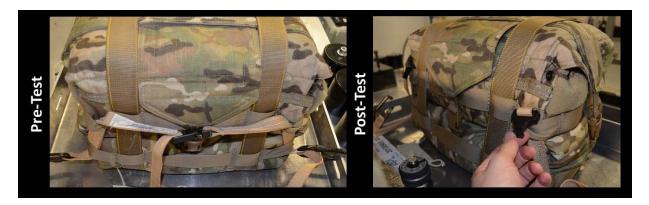
Figure 7 shows the pre and post-test state of the medium ICB with the UTD restraint system. The UTD buckle became unbuckled during multiple tests; however the UTD was able to restrain the ICB due to the routing through the lateral straps. The UTD was inspected and reattached after each test. Review of the high speed video reveled that although the buckle came loose almost immediately, however, with the integrated ICB straps routed through the tray the ICB was successfully restrained. This was shown to be repeatable over multiple tests. The overall excursion of the bag from the test tray was greater than that seen by the paracord.

Figure 8: Medium ICB with UTD pre-test (left) and post-test (right) state

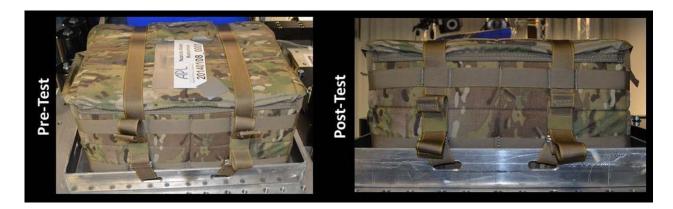
Figure 9 shows the pre and post-test state of the large ICB with the 550 Paracord restraints. No failures or loosening were noted in this configuration and the Paracord was retightened after each test. High speed video shows the majority of the displacement at the center of the bag, with the overall displacement of the bag being less than what was recorded for the tests involving the medium ICB.

Figure 9: Large ICB with 550 Paracord pre-test (left) and post-test (right) state

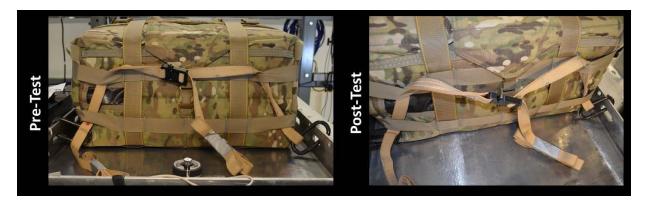
Figure 10 shows the pre and post-test state of the large ICB with the UTD restraint. No failures or unbuckling were noted in this configuration. The UTD was inspected and reattached after each test. Similar to the tests involving the paracord, high speed video shows the majority of the displacement at the center of the bag, with the overall displacement of the bag being less than what was recorded for the tests involving the medium ICB. Unlike the medium ICB the UTD did not come unbuckled during the testing.

Figure 10: Large ICB with UTD pre-test (left) and post-test (right) state

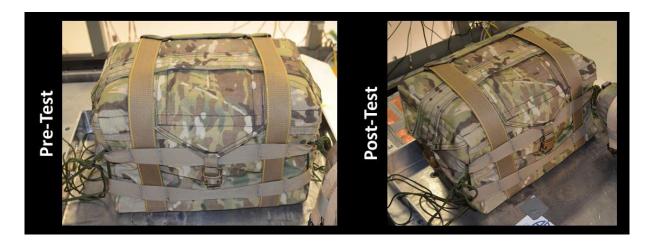
Figure 11 shows the pre and post-test state of the Aerogel with the 550 Paracord restraints. No failures or looseness in the Paracord were noted during these tests and the Paracord was retightened after each test. High speed video showed that the system moved upwards before being restrained, similar to the medium ICB. Similar response characteristics were noted for both the 7 and 9 m/s tests.

Figure 11: Aerogel with 550 Paracord pre-test (left) and post-test (right) state

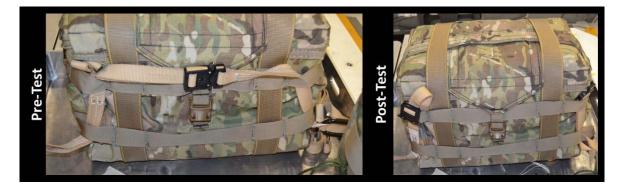
Figure 12 shows the pre and post-test state of the Aerogel with the UTD restraint. Of all the tests, only one failure of the buckle occurred. The UTD was inspected and reattached after each test. Similar to the medium ICB, review of the high speed video reveled that although the buckle

came loose almost immediately, however, with the integrated ICB straps routed through the tray the ICB was again successfully restrained.

Figure 12: Aerogel with UTD pre-test (left) and post-test (right) state

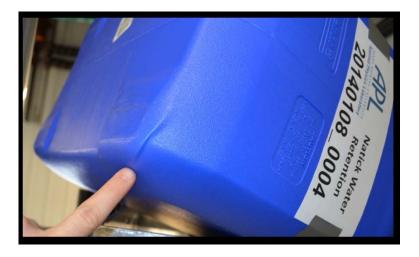
Figure 15: COTS sustained damage at 9.0 m/s exposure

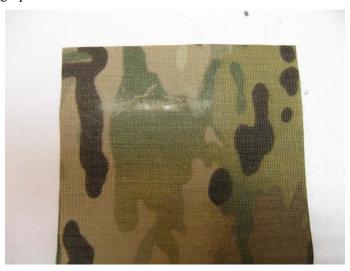
- Sample 1 Cordura was tested per the instrument set-up above.
- The sample was held in place using the Narrow Slot Sample Holder.
- The Sample was clamped to the T-slot table. The Holder was used to secure the samples to the Linear T-slot table. A Specimen Mounting Card was not necessary as the Holder applies even pressure to secure the samples.
- Per customer request the test was set to run for one hour (= 3,600 cycles).
- The test was started and monitored the entire time.
- The test continued to 1,392 cycles where total break-through was observed.
- See photograph below.

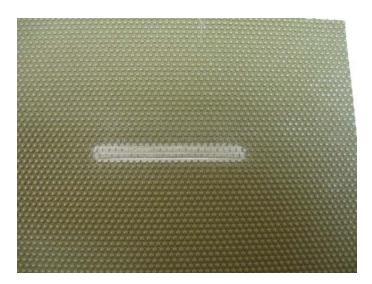
I note that the "dots" on the Superfabric wore grooves in the Wearaser. Once the "dots" were abraded through, the Wearaser abraded more on one side and wore through the fabric. EVEN if the Wearaser was refaced during the test, I do not believe the sample would have made it to 10,800 cycles
